**WELLS PROJECT 230 KV TRANSMISSION LINE
AVIAN PROTECTION PLAN**

WELLS HYDROELECTRIC PROJECT

FERC NO. 2149

June 2009

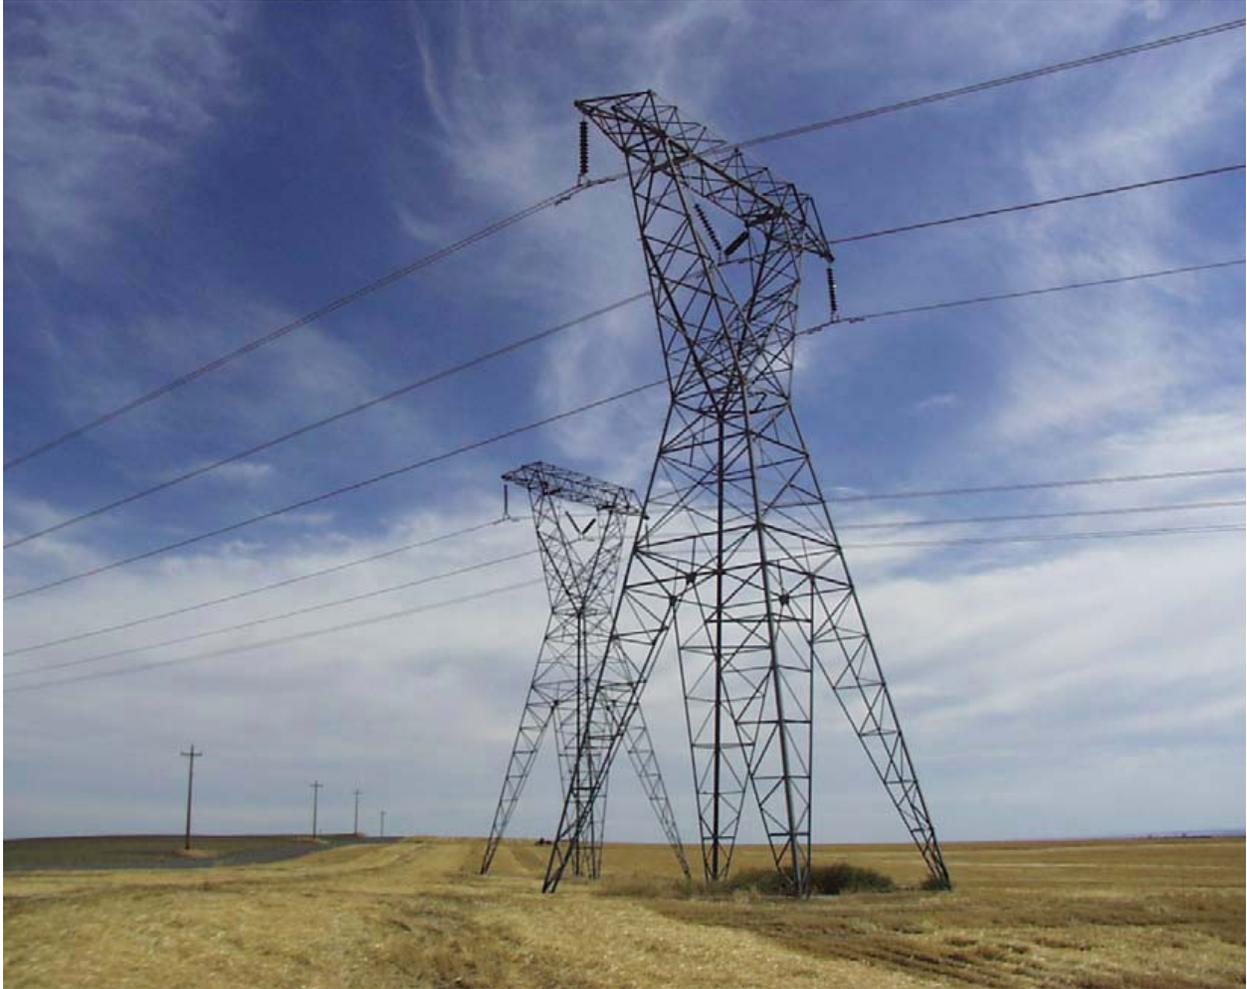
Figure 1.2-1 **Wells Project Transmission Line**

Two 230 kV single-circuit transmission lines were built for the Wells Project (Figure 1.2-1). Each of the 230 kV transmission lines is capable of transmitting the entire output of the Wells Project. The lines run 41 miles (65.6 km) from the switchyard atop the dam to the Douglas Switchyard operated by Douglas PUD. The lines run parallel to each other on 45-85 foot steel towers along a common 235-foot wide right-of-way. Each phase has two parallel conductors suspended 96 inches to 105 inches (2.4 to 2.6 m) below the bridge and approximately 24 feet (7.3 m) between phases. The transmission lines begin at Wells Dam and cross the Columbia River from Carpenter Island in Chelan County to Douglas County (Figure 1.2-2). After crossing the river, the transmission lines travel southeast to the Boulder Park area then turn southwest across wheat fields, past the town of Waterville and over Badger Mountain. The Douglas Switchyard is located in close proximity to the Rocky Reach Switchyard, operated by Public Utility District No. 1 of Chelan County (Chelan PUD) and the Sickler Substation, operated by the Bonneville Power Administration (BPA). The 230 kV lines connect to the regional transmission grid at BPA's Sickler Substation.

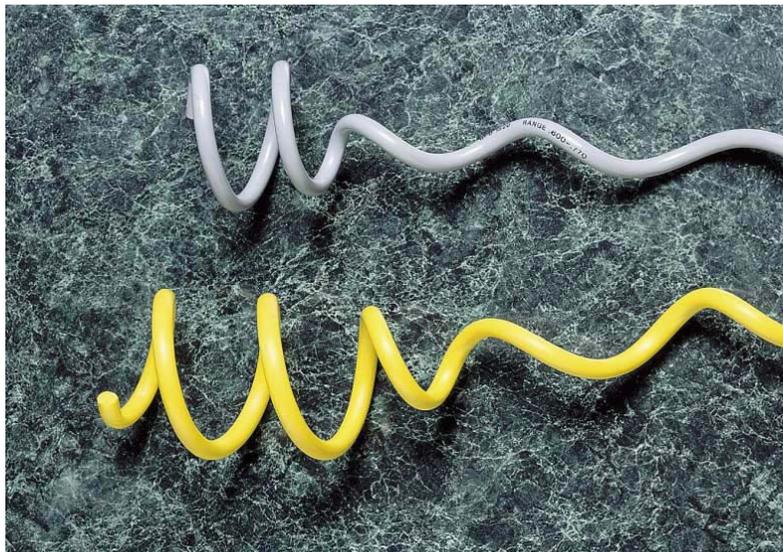
Figure 5.2.1 Bird Flight Diverters manufactured by Tyco Electronics

Bird flight diverters (BDs) have been used in Europe and the United States since the early 1970s (APLIC, 1994). BDs are a preformed high impact plastic spiral which wraps around the shield wire to make the wire more visible (Figure 5.2-1). BDs increase the apparent shield wire diameter to 2.5 to 5.5 inches (6.4 to 13.9 cm) making the line more visible to birds. BDs are normally installed at a 49 foot (15 m) spacing. Reductions in bird collisions of 65 to 74 percent have been experienced using BDs.

BDs will be installed on the Wells transmission line river crossing in the event that the transmission line is reconductored, or if the static wire or aviation markers are replaced. BDs will be spaced between the aerial marker balls to increase visibility of the shield wire. If available, light emitting BDs will be installed to improve low light visibility; Puget Sound Energy is working with Tyco Electronics to develop BDs that store solar energy and emit visible light during low light conditions.
